## CHAPTER IX:

### STAIRWAY VARIATIONS

#### TIMBER STAIRCASES

### 1) Fisherman's Bridge, Arkansas River, Salida, Colorado

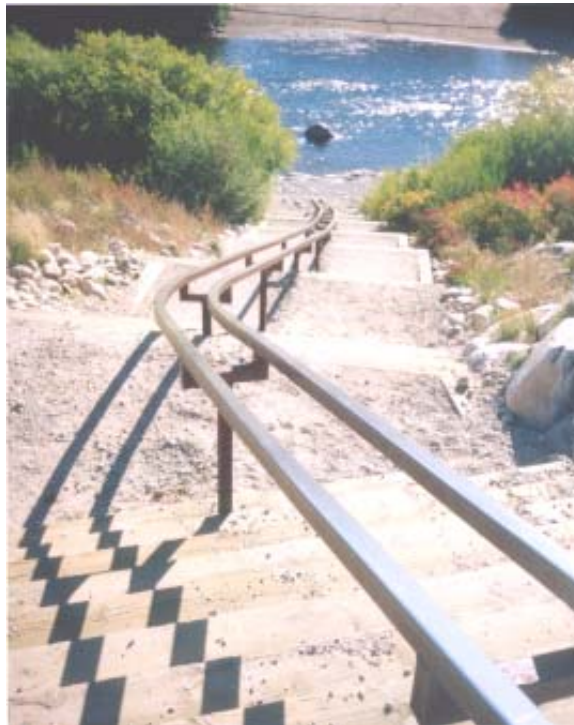
**Photo 9A: Timber stairs and metal boat slide facilitate access from a steep bank**

*Solution:* A 15 foot-wide timber staircase, with a metal slide for rafts and boats, was installed into the slope. Parallel metal bars running down the center of the staircase provide allow paddlers and rafters to slide boats and rafts to the water below.

Construction of the staircase was designed to maximize bank stabilization. Each stair level consists of a timber box filled with "roadbase," a mixture of rough soil and class 6 gravel. Boulders placed around the launch area, at the base of the staircase, provide protection from undercutting.

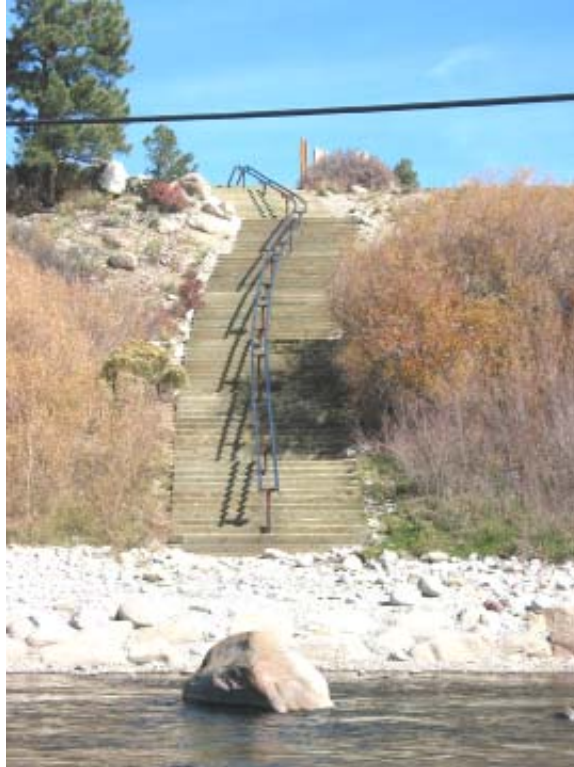
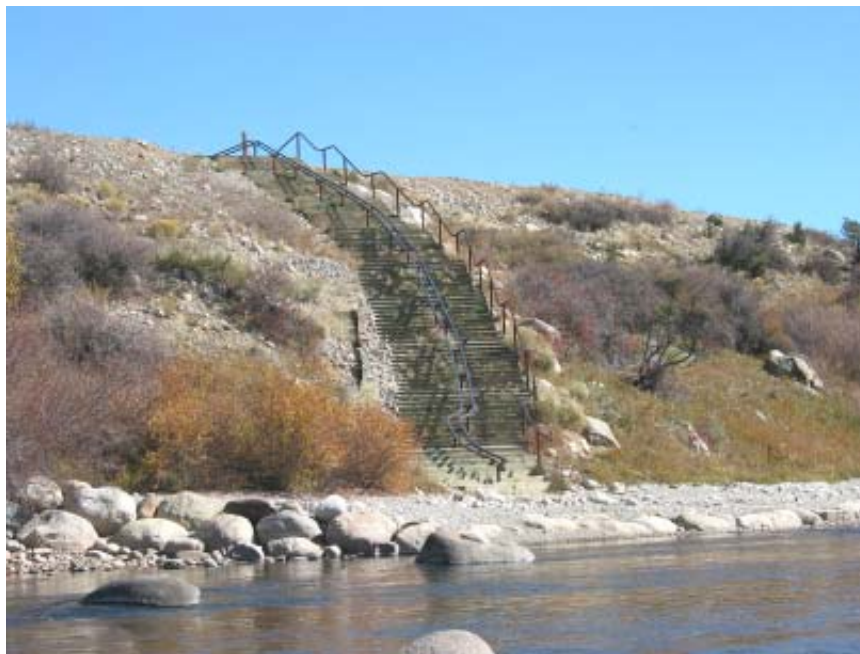
**Photos 9B, 9C: Two views of staircase at Fisherman's Bridge from the river**

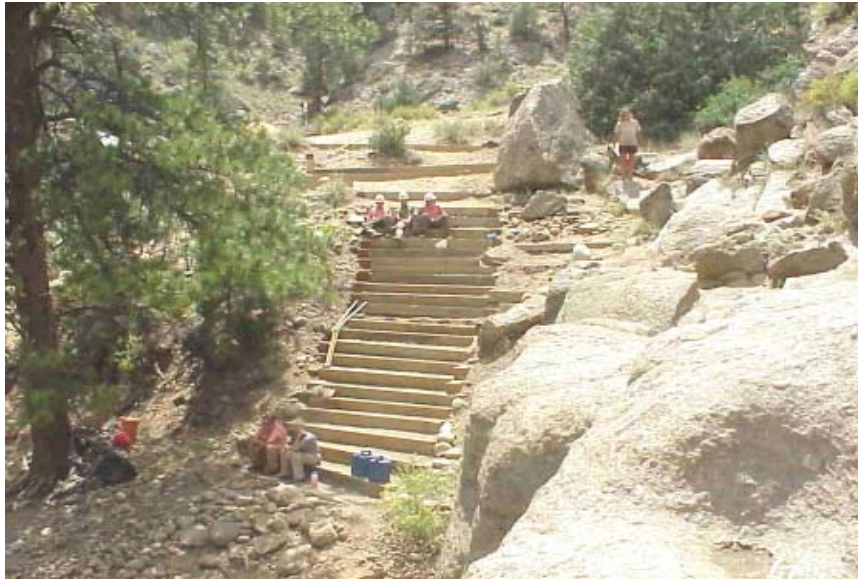
**Photo 9D: Rectangular timber stairs with varying treads provide access to steep shoreline while helping to mitigate erosion**

Jump Rock, another site along the Arkansas River, has a stairway constructed of 8" x 8" x 8' treated timbers. On the steeper part of the hill the timbers are placed close together with the tread and rise at 8" in some areas. As the hill becomes less steep, the tread increases but the rise remains at 8" in order to reduce erosion and need for maintenance. At the top of the hill, where it is least steep, the tread and rise decrease to the point where the top few stairs are relatively shallow.

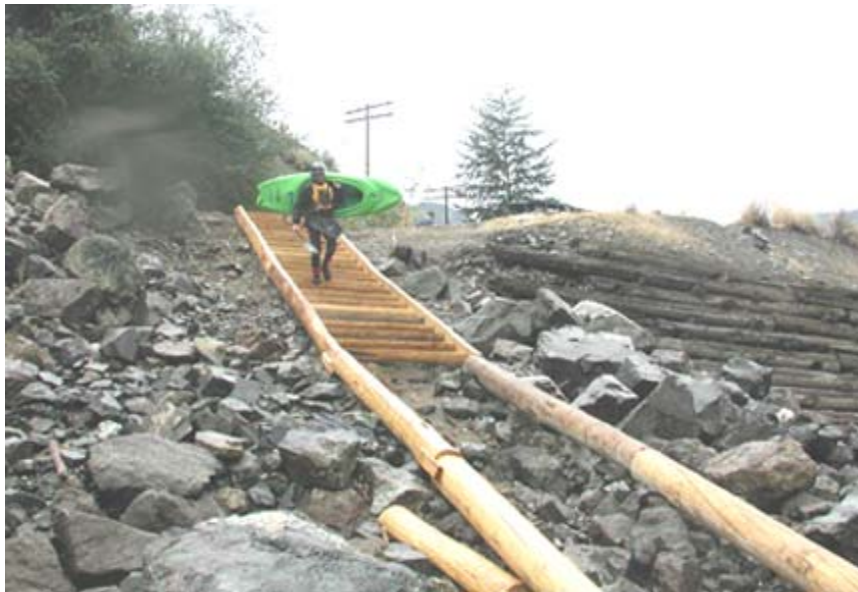
**Photo 9E: Rounded timbers serve as staircase for paddlers**

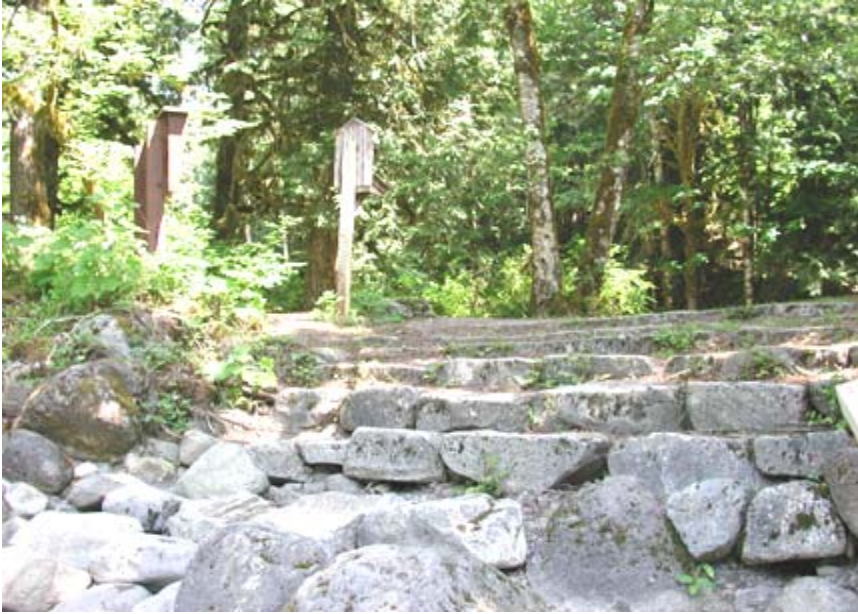
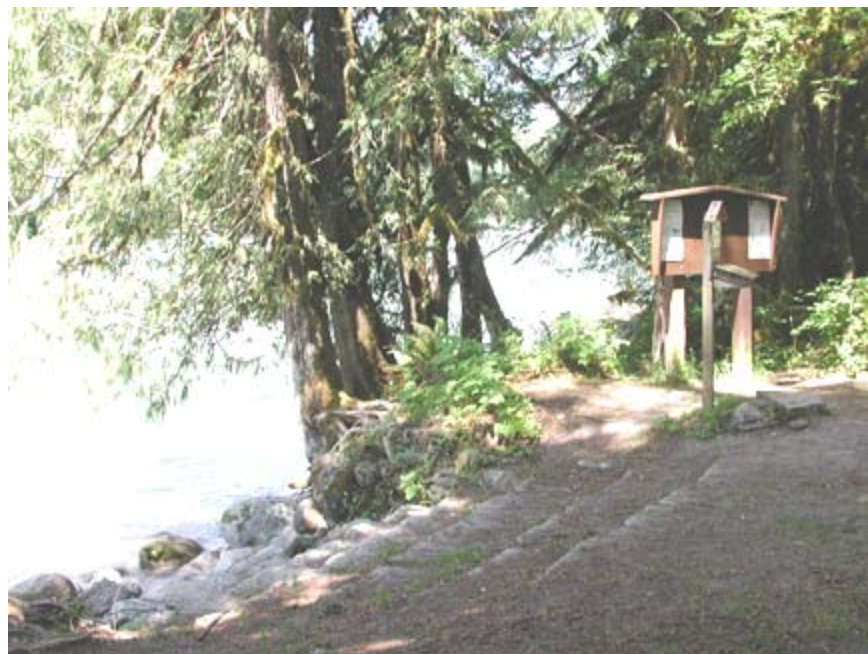
**Photos 9F, 9G: Rock staircase provides river access with a “natural” appearance**

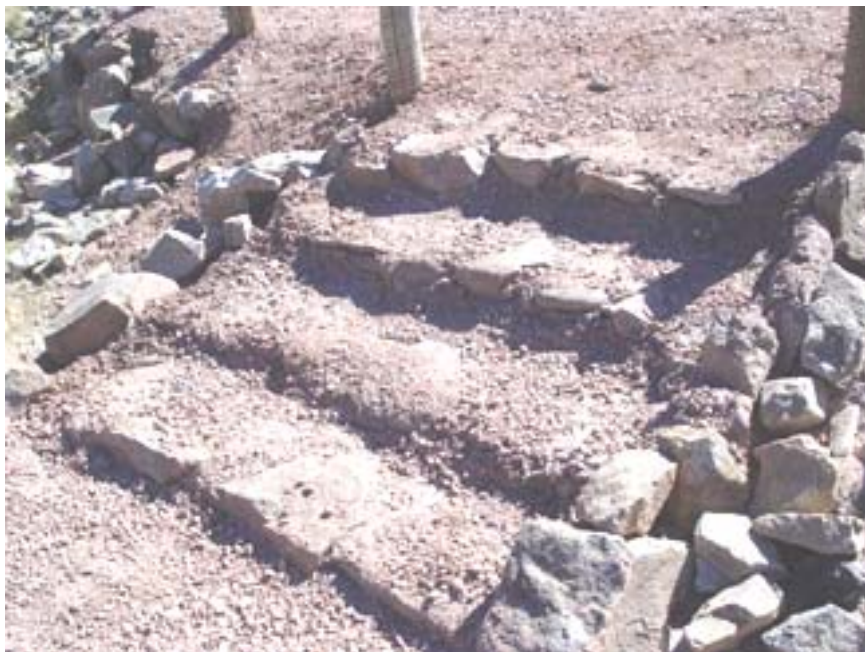
**Photo 9H: Rock staircase reinforced with rip-rap form a simple staircase to launch area**
